# GAS PIPELINE

## IDENTIFYING GIRTH WELD CRACKING THREATS IN A CRA CLADDED PIPE

### CASE STUDY

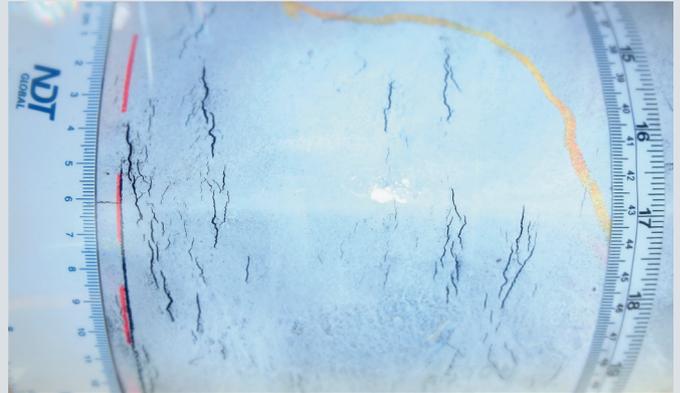
Example of cracking in girth weld

**Independently verified:** Highly accurate circumferential crack detection. The circumferential crack detection run found weld crack-like anomalies which were independently verified by Bureau Veritas (a global leader in testing, inspection and certification (TIC), delivering high quality services to help clients meet the growing challenges of quality, safety, environmental protection and social responsibility.). Inspection performance was confirmed to be within the specification as per guidance in API 1163. The crack-like defects were only 1 mm (0.04 in) deep, but were successfully identified by the inspection.
