STATOIL

CUSTOM SOLUTION FOR AN EXTREME SUBSEA PIPELINE

CASE STUDY

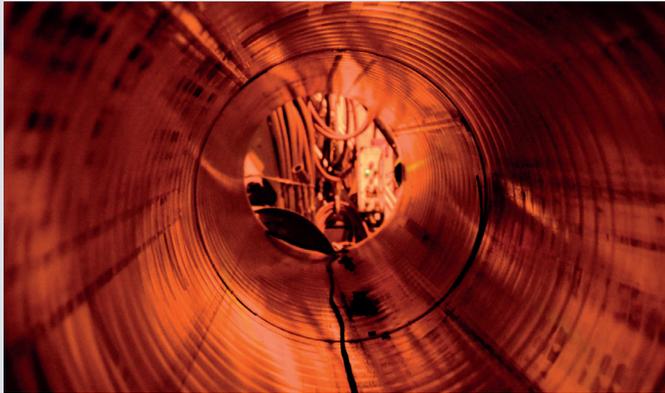
A varying wall thickness range of 28.9 mm to 37.5 mm (1.1 in to 1.5 in)

However, MFL depth sizing accuracy is reduced in direct proportion to the pipe wall thickness. This pipeline has a varying wall thickness range of 28.9 mm to 37.5 mm (1.1" to 1.5") which meant that ultrasonic technology (UT) offered a solution which was up to 80% more accurate for depth sizing. UT inspection was feasible as prior to operation, the pipeline was filled with treated seawater.

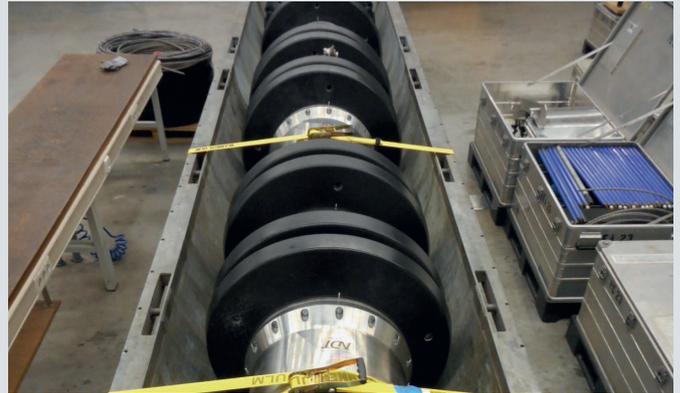
Customized inspection tool with master and slave battery modules

A new 36" battery module was built for this project. The applications and tooling teams also converted a 36" battery module into a slave battery module so that 2 battery modules could be used in the same tool to meet the extended run time of 470 hours.
