CRA — inspected

Herbert Willems, NDT Global, Germany, explores corrosion and cracking in corrosion resistant alloys that are used in the oil and gas pipeline industry.

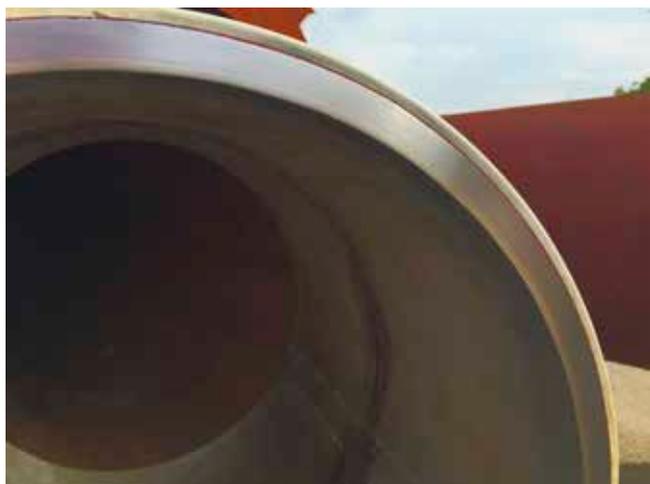
Figure 1. Cross section of a CRA lined pipe.

Clad pipes consist of an internal CRA layer, which is metallurgically bonded to the backing carbon steel. Different manufacturing processes (e.g. hot rolling or weld overlay) are used to bond the CRA layer to the carbon steel. In contrast to clad pipes, lined pipes have a CRA lining that is mechanically bonded to the carrier pipe.

In this case of lined pipe, the pipe has a CRA inliner that is mechanically bonded to the carrier pipe, such as by hydraulic expansion. UT tools can only inspect the inner layer, as ultrasonic pulses cannot propagate through this type of bonding.

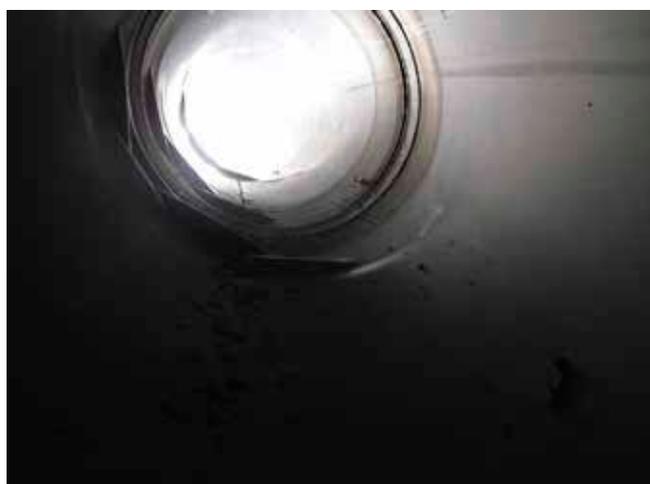
Figure 2. Example of wrinkling and buckling in a CRA lined pipe.
