CASE STUDY

# **SIMULTANEOUS CRACK AND METAL LOSS INSPECTION**

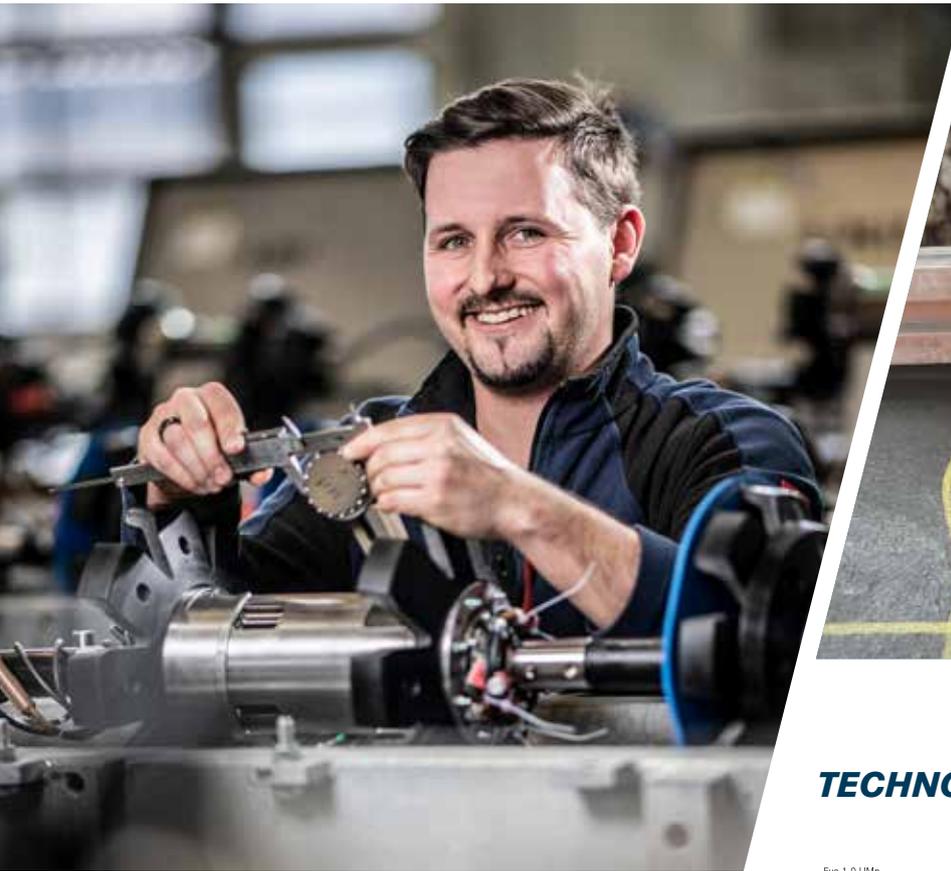
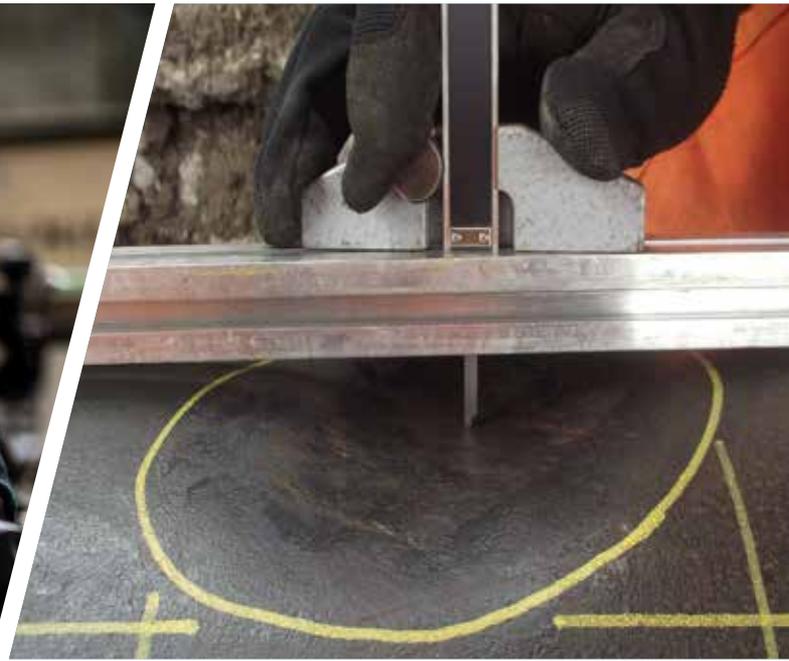
After evaluating available solutions, the operator asked NDT Global to inspect the pipeline. A combination run consisting of Evo 1.0 UC, Evo 1.0 UMP and Atlas UG robots delivered a comprehensive inspection in a single run. These technologies accurately detect, locate, and size metal loss and axially oriented crack-like anomalies, providing high-resolution mapping and XYZ coordinates for the pipeline. In particular, the company's innovative Enhanced Sizing for ultrasonic crack inspections removes depth sizing boundaries that previously existed for depths above 4 mm (0.16 in).

NDT Global's technology is unique in its ability to perform a combination UT compression wave type ILI robot run, with XYZ mapping, for the detection of metal loss and lamination anomalies, while having the ability to simultaneously complete crack detection.
